REPLACEMENT THRUST BEARING WASH

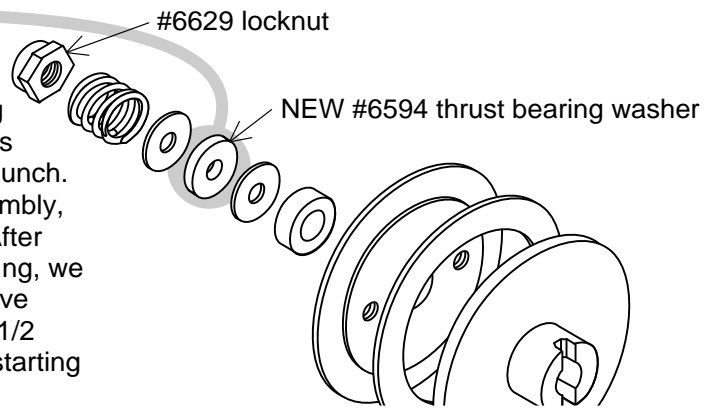
Team Associated has replaced the retainer type thrust bearing (#6586) with a washer type thrust bearing (#6594) in the Torque Clutch assembly. This change has improved the performance of the clutch, giving it more punch.

NOTE: Because of the increased torque on the assembly, extra care must be taken with the #6629 5-40 locknut. After you have removed the locknut three times during servicing, we suggest replacing the locknut with a new one. So we have included a spare. Adjust your clutch until there is about 1/2 thread showing outside the nut. This should be a good starting point.
