An important note to all Ace Jaguar Radio Owners....

If you have recently purchased one of our Ready-To-Run GT Plus kits, T3 RTR or a Nitro TC3 RTR, you may experience a rapid, persistent "beeping" alarm signal emitted when you turn on your Ace Jaguar transmitter. This alarm (intended to warn you that you are at full throttle or full brake) temporarily disables the transmitter for safety reasons, but may not properly re-set in some cases. Fortunately, you can easily remedy this yourself in a few simple steps with a phillips screwdriver, straight-blade screwdriver, and a small pair of pliers or a 5/16" nut driver.

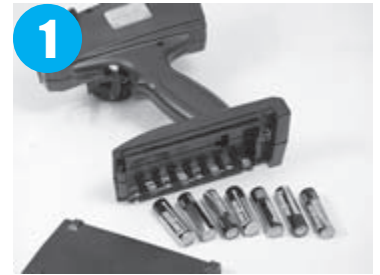
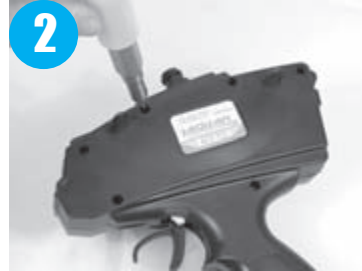
1. First, remove the battery cover and the eight AA batteries from the transmitter.
2. Next, open the radio by removing the 8 screws that hold the case together. There are six screws in the outer case, and two longer screws inside the battery compartment.

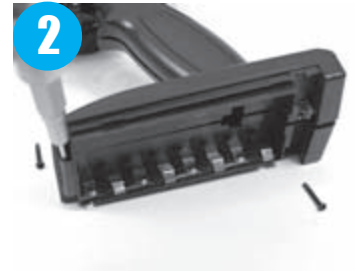
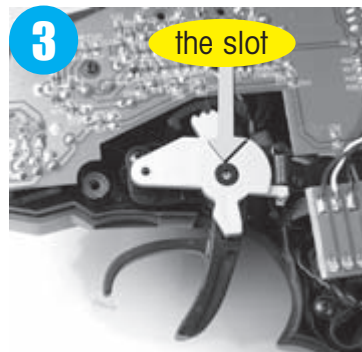
3. Open the case halves, and lay the transmitter open as shown, exposing the throttle trigger assembly. Look at the slot in the end of the throttle pivot post. If it is pointing vertically (nearly straight up and down), proceed to the next steps.

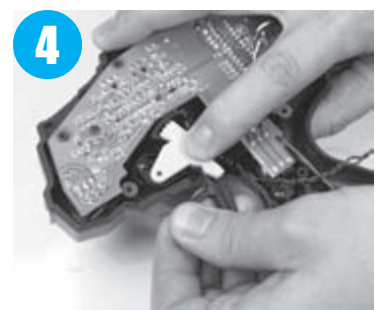
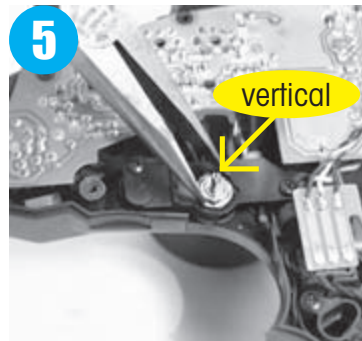
4. Pull the trigger assembly straight up and off, set aside.
5. Tighten this gold 5/16" nut snugly. Then, turn the trigger pivot post until the slot is straight horizontal.

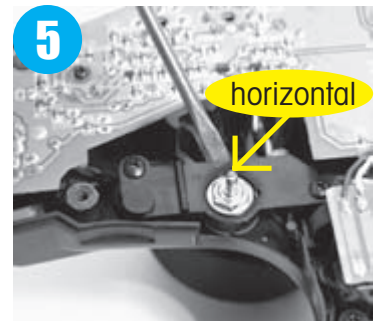
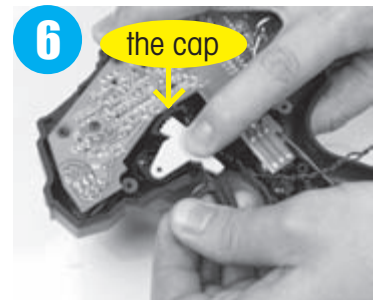
6. Press the trigger assembly back onto the pivot post. Be sure the white plastic part of the trigger installs inside the black plastic "cap" as shown.
