Beeping Transmitter Repair

If you have purchased one of our RTRs that include either an XP2 or XP3 27MHz transmitter system, and you are experiencing a rapid, persistent “beeping” alarm signal emitted when you turn on XP2 or XP3 transmitters, then this repair is for you. Normally, this alarm warns you that your transmitter is either at full throttle or full brake, and temporarily disables the transmitter for safety reasons. (It may not be reset in some cases.) If you hear the alarm and you do not have full throttle or full brake applied, the problem is that the trigger assembly is off center. Fortunately, you can easily remedy this yourself with the use of Phillips and straight-blade screwdrivers, a small pair of pliers (or a 5/16” nut driver), and some CA Glue.

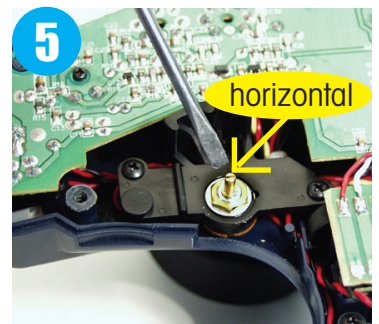
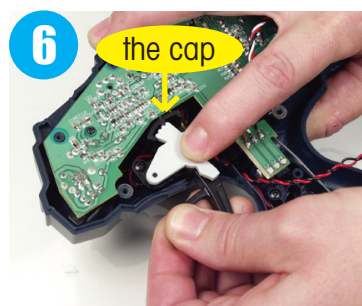
- 6** Press the trigger assembly back onto the pivot post. Be sure the white plastic part of the trigger installs inside the black plastic “cap” as shown.
